DEPARTMENT OF TRANSPORTATION**DIVISION OF ENGINEERING SERVICES**

Office of Structural Materials

Quality Assurance and Source Inspection

Contract #: 04-0120F4Cty: SF/ALA Rte: 80 PM: 13.2/13.9File #: 82.28**WELDING INSPECTION REPORT****Resident Engineer:** Casey, William**Address:** 333 Burma Road**City:** Oakland, CA 94607**Report No:** WIR-026425**Date Inspected:** 19-Sep-2011**Project Name:** SAS Superstructure**OSM Arrival Time:** 600**Prime Contractor:** American Bridge/Fluor Enterprises, a JV**OSM Departure Time:** 1430**Contractor:** Westmont Industries**Location:** Santa Fe Springs, CA**CWI Name:** Patrick Fitzgerald**CWI Present:** Yes No**Inspected CWI report:** Yes No N/A**Rod Oven in Use:** Yes No N/A**Electrode to specification:** Yes No N/A**Weld Procedures Followed:** Yes No N/A**Qualified Welders:** Yes No N/A**Verified Joint Fit-up:** Yes No N/A**Approved Drawings:** Yes No N/A**Approved WPS:** Yes No N/A**Delayed / Cancelled:** Yes No N/A**Bridge No:** 34-0006 L & R**Component:** Maintenance Travelers**Summary of Items Observed:**

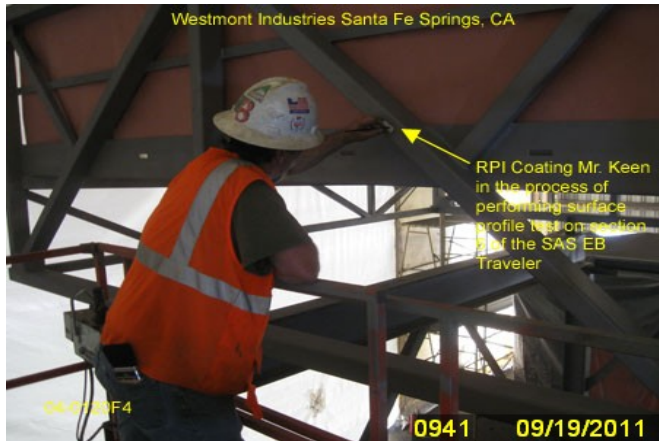
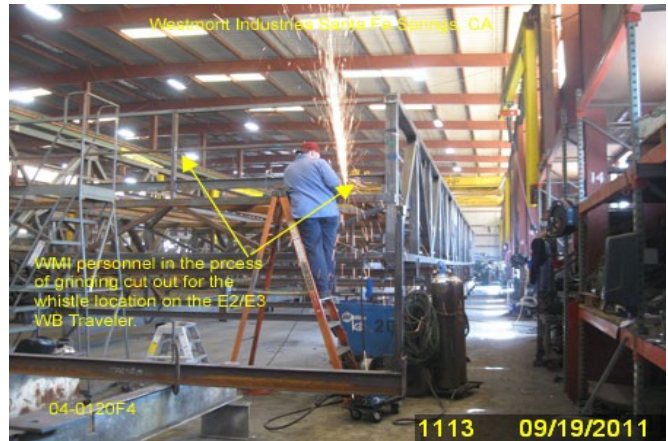
This QA Inspector performed random shop observations and observed that RPI Coating continuing sweep blast and prime coat application on the SAS EB Traveler. QA Inspector was informed by RPI Coating Quality Control (QC) Representative Mr. Preston Keen that RPI is going to sweep blast a another section and apply the Sherman Williams Zinc Clad II prime coat to the today. Later in the morning this QA Inspector randomly observed that RPI personnel performing sweep blasting activities on the SAS EB Traveler. After sweep blasting was completed, QA Inspector then observed Mr. Keen performing random surface profile checks on the sweep blasted base metal surfaces. This QA Inspector observed Mr. Keen utilizing a Testex Press-O-Film and a micrometer to perform the testing. During observation, this QA Inspector observed that the readings appeared to be 3.7 mils, 3.7 mils, and 3.3 mils. Testing observed by QA Inspector appears to be in compliance with the contract requirements. After testing was completed this QA observed RPI Coating personnel masking areas to prevent overspray.

Prime coated on 9-12-11 (section 1), adhesion test 725 psi (pass), Pencil Test (pass), Quarter Test (pass) and Rub test not performed.

Prime coated on 9-13-11 (section 2), adhesion test 435 psi (fail-glue), Pencil Test (pass), Quarter Test (pass) and Rub test not performed.

Prime coated on 9-14-11 (section 3), adhesion test 700 psi (pass), Pencil Test (pass), Quarter Test (pass) and Rub test not performed.

Prime coated on 9-16-11 (section 5), adhesion test 525 psi (fail-paint), Pencil, Quarter, and Rub test not performed.

Mr. Keen stated that he would glue additional dollies approximately 2 inches from the failing areas in section 2 and section 5 and would continue testing tomorrow.
